Inventory No:	CON.1812
Historic Name:	Burke Garage
Common Name:	
Address:	55 Old Bedford Rd
City/Town:	Concord
Village/Neighborhood:	Merriam's Corner
Local No:	
Year Constructed:	c 1908
Architect(s):	
Architectural Style(s):	No style
Use(s):	Out Building
Significance:	Architecture
Area(s):	CON.C: Minute Man National Historical Park CON.BL: Lower Old Bedford - Virginia Roads Area CON.EC: Minute Man National Historical Park
Designation(s):	Nat'l Register District (10/15/1966); Nat'l Historic Landmark (10/15/1966); Nat'l Register District (11/29/2002)
Building Materials(s):	Roof: Asphalt Shingle Wall: Wood; Wood Shingle Foundation: Concrete Unspecified

NON-CONTRIBUTING STRUCTURE INVENTORY FORM

Structure Name(s): BURKE HOUSE GARAGE

Address or Location: 25 OLD BEDFORD RD.

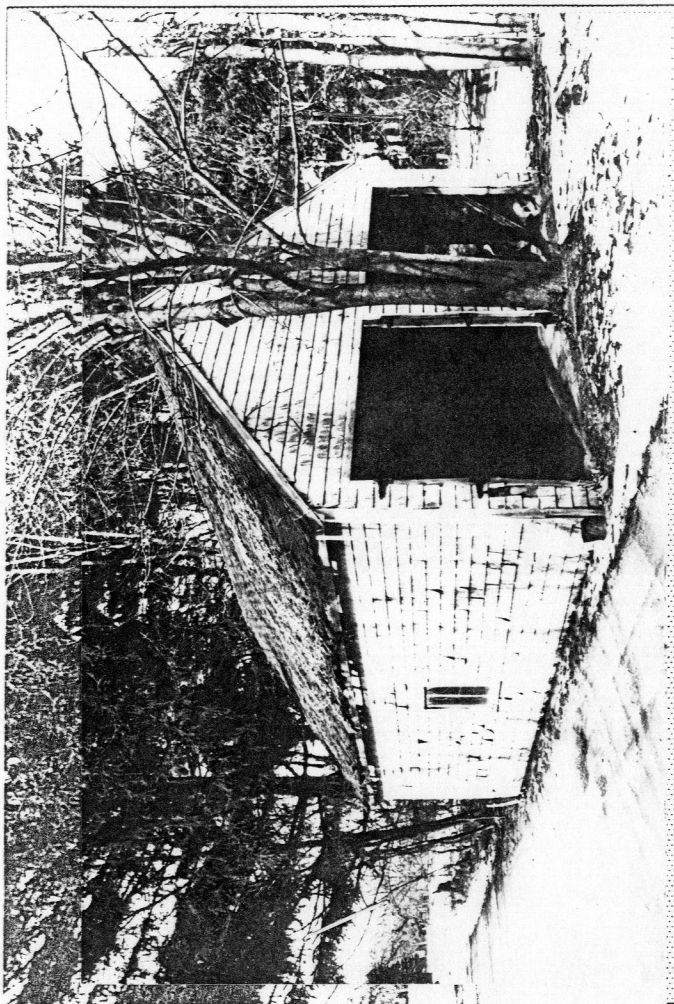
Condition: ☐ GOOD ☒ FAIR ☐ POOR

DESCRIPTION: Gabled one-story two-car garage. Severe deterioration of the asphalt roofing shingles at the south-facing roof plane; wood shingles weathered. Missing garage doors. Otherwise, the structure is in fair to good condition. Concrete floor.
